PEX 8548

PCI Express Switch

Silicon Revisions and Errata List

Version 1.7

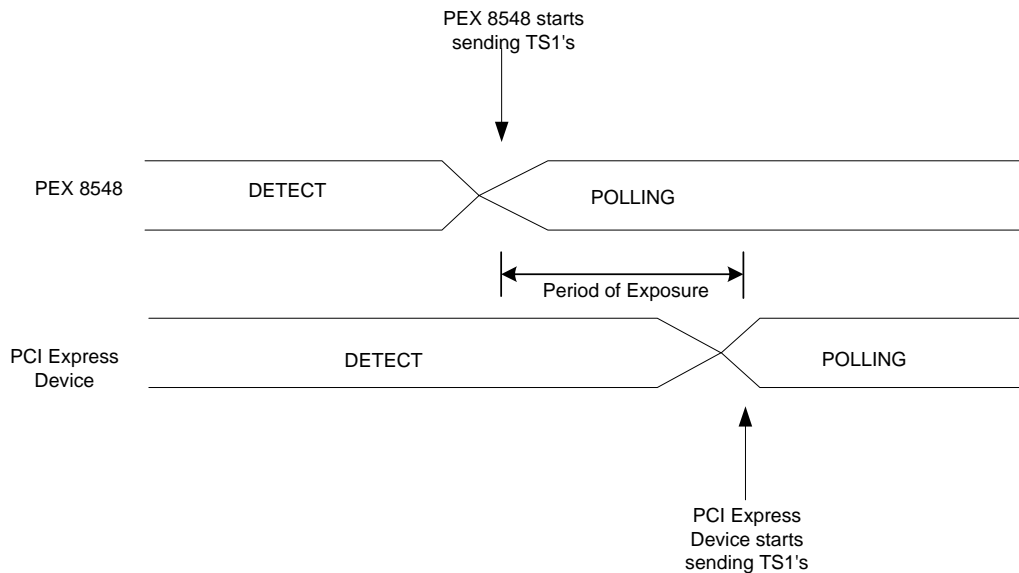
Erratum #7 – Possible Link Down-Train During Link Initialization

When the PEX 8548 is connected to devices that start transmitting training sets to the PEX 8548 after the PEX 8548 has been transmitting training sets (PEX 8548 in Polling state), there is a period of exposure where the receivers in the PEX 8548 are in 'electrical idle' state while the transmitters in the PEX 8548 are sending valid data. During this period, the Elastic Buffer could be set in a state that prevents the lane from participating in the final link configuration.

If the workaround is not implemented, the PEX 8548 link may down-train to a smaller width when it enters the Polling state, thus affecting performance. During link up cycles where the switch comes up in the configured width, there is no run time exposure.

1. Skew the reset inputs such that the adjacent device starts transmitting ordered sets first. The Elastic Buffer will not enter the illegal state when the PEX 8548 detects valid data on its receiver lanes during its transition from Detect state to Polling

state. For slots where it is difficult to control polling entry by skewing reset, the downstream port could be held in link down state by setting the Port Disable bits (0x236 bits 0-2) through EEPROM and enabling the port prior to discovery.

2. Re-start training sequence on link. When the adjacent device attempts to train at a link width less than its programmed width, the PLX port can be instructed to re-start its link training sequence by issuing a link disable closely followed by a link enable. The PEX 8548 link can be disabled/enabled via register 0x78 bit 4 of the appropriate port configuration space.

3. Use Different Reference clocks. The Elastic Buffer is able to recover from this condition in the Polling state when different reference clocks are used. The link will be reliable once it transitions to the Active state.

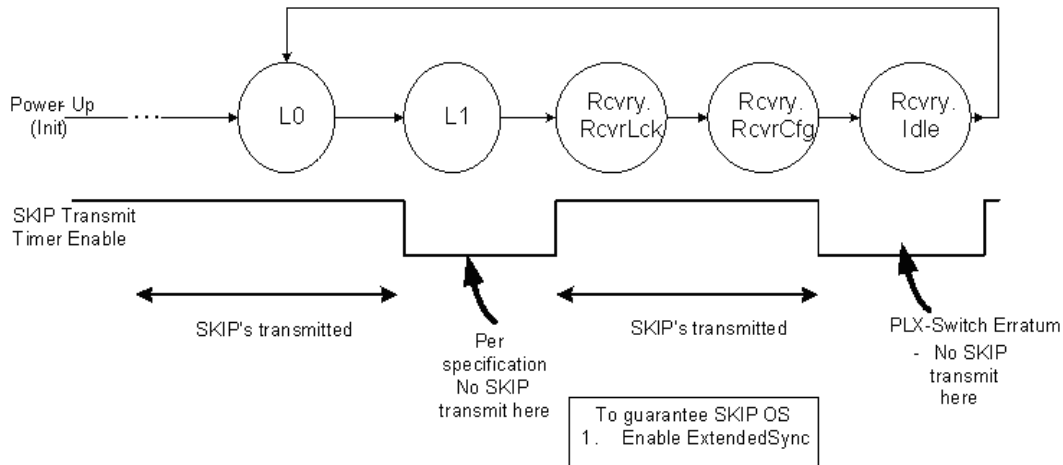
Erratum #10 – Dropped SKIP Ordered Set when Exiting L1 Power Management State

When exiting from the L1 Power Management (PM) state, there is a narrow window (recovery.idle state) during which no SKIPS are transmitted. The exit from L1 PM state steps through 3 sub-states – 1) rcvry.rcvrlock, 2) rcvry.rcvrconfig and 3) rcvry.idle. For the duration in which the link is in Recovery.idle state (waiting for receipt of 8 Idle

symbols) there will be no SKIP ordered sets transmitted. Note, SKIPs will be transmitted properly when entries into recovery sub-states are from another (L0 or L0s) state.

The Figure below illustrates the behavior.

PCI Express devices whose PHY can only deskew using SKIP ordered sets and need it to exit the recovery path shown above could fail L1 entry/exit and reach the L0 state >100ms later, taking the link down along the way. The workarounds listed above fix this, with Workaround 1 implying that the PEX 8548 will not realize any L1 power savings.

Disable the PEX 8548 upstream port's entry to L1 state for ASPM L1 [78h[1:0]] and PCI PM (device specific offset 1E0[7]) mechanisms.
